HISTORIC STRUCTURE REPORT

Architectural Data Section

LINDENWALD

MARTIN VAN BUREN NATIONAL HISTORIC SITE

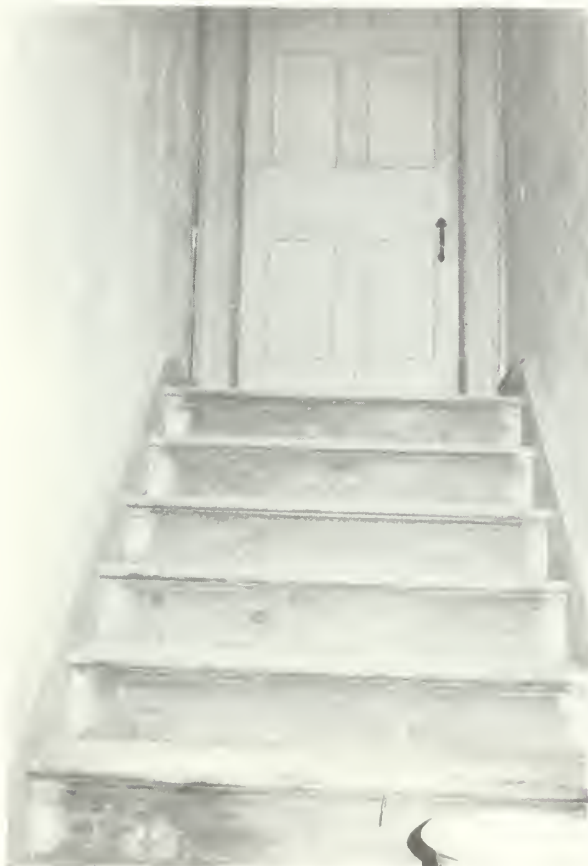
IP065, N032-09.
Room 307, looking east
up stairs to door 307.

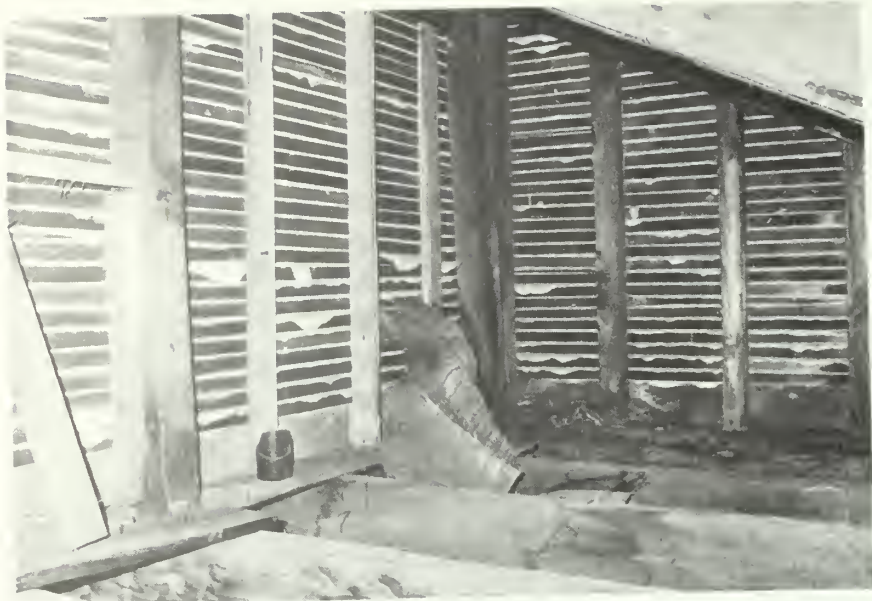
IP066, N006-08. Room 311, looking northwest. Note reused lengths of fluted moldings and discarded remnant of grass matting (now in park collection).

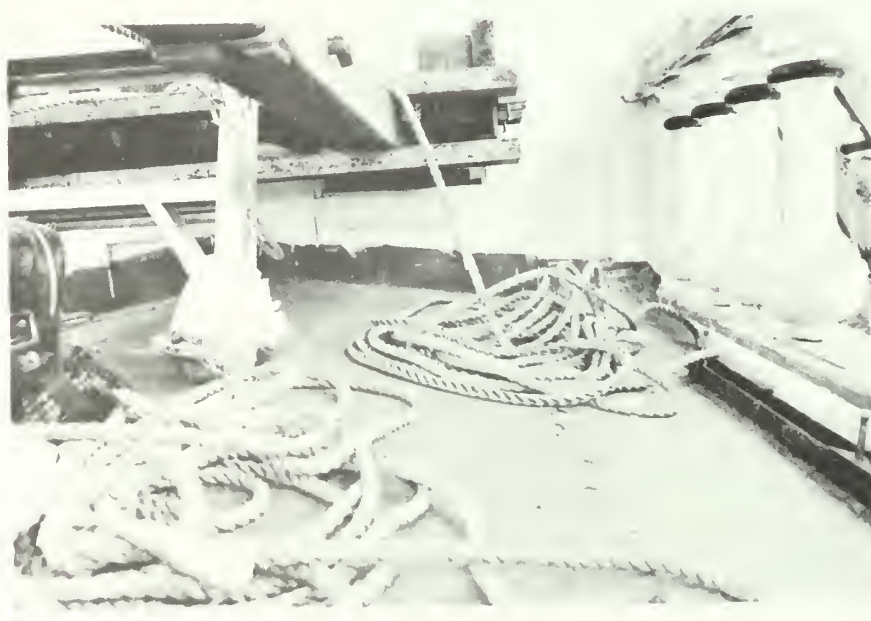
IP007, N032-02. Belvedere (room 501), deck.

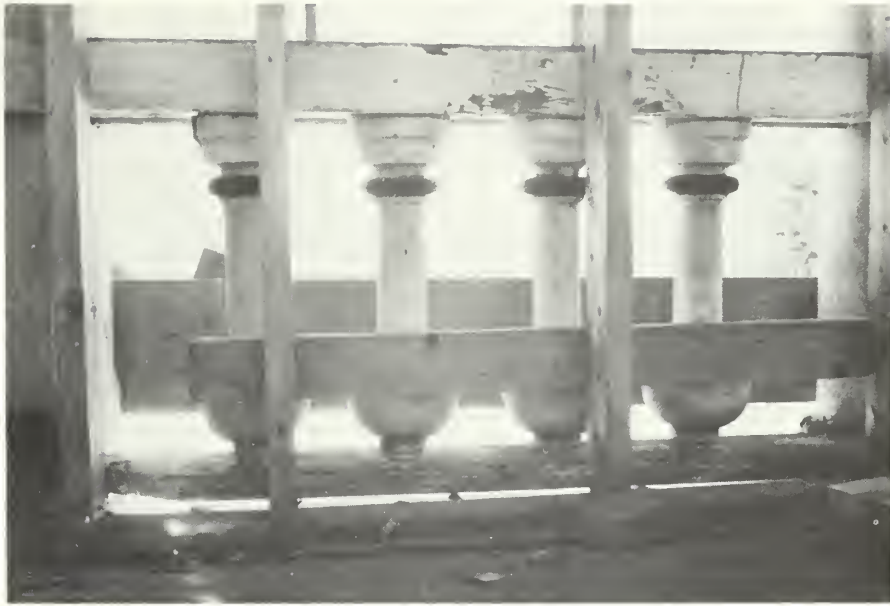
IP068, N032-02. Room 501, balusters in belvedere railing.

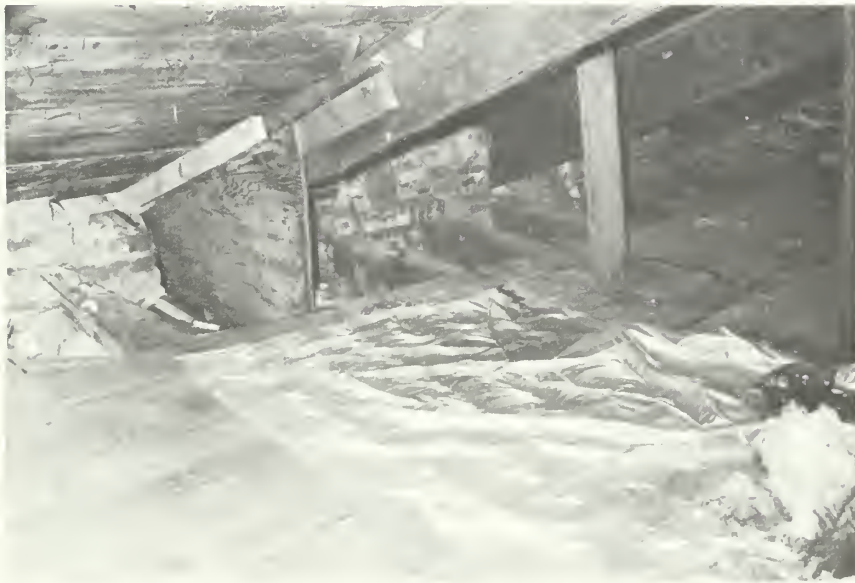
IP069, N002-07. Rafter ends room 301.

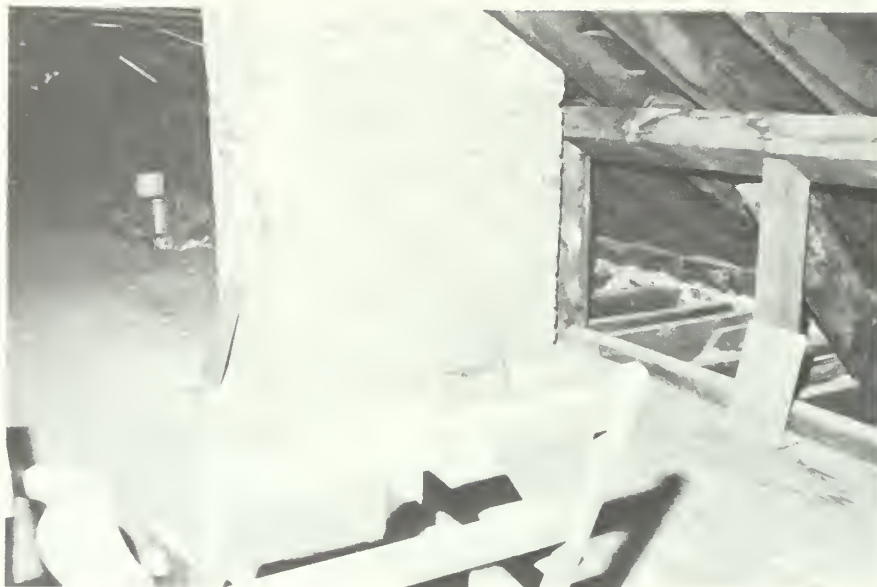
IP070, N031-22. Chimney and lower stud wall. Upjohn attic (room 213).

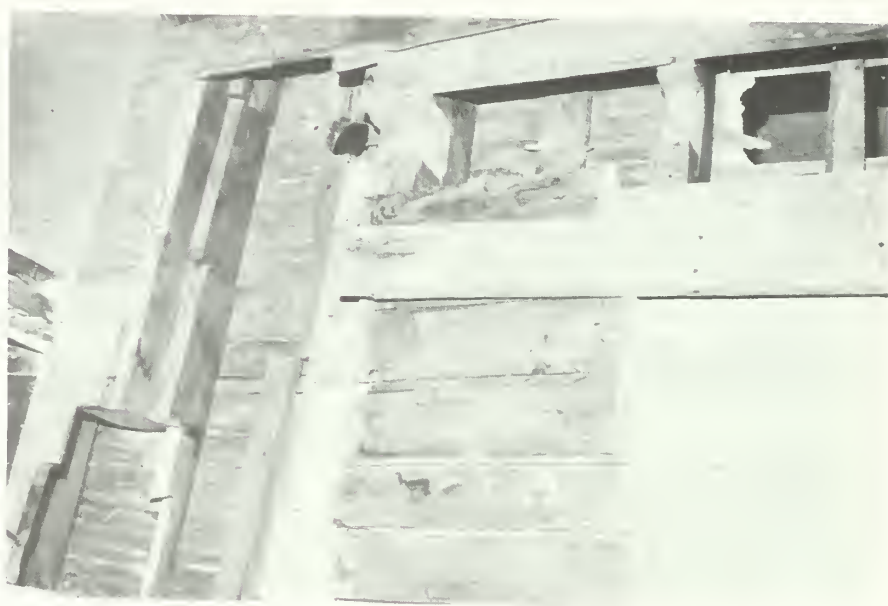
IP071, N031-08. Room 201/203 floor framing and notched joists.

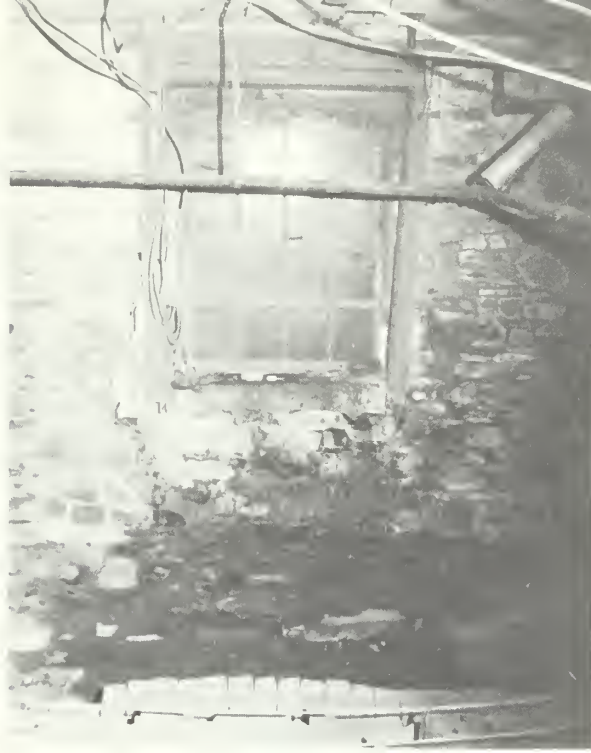
IP072, N028-35. Window 011. Note water penetration and dislodged masonry at lower left corner.

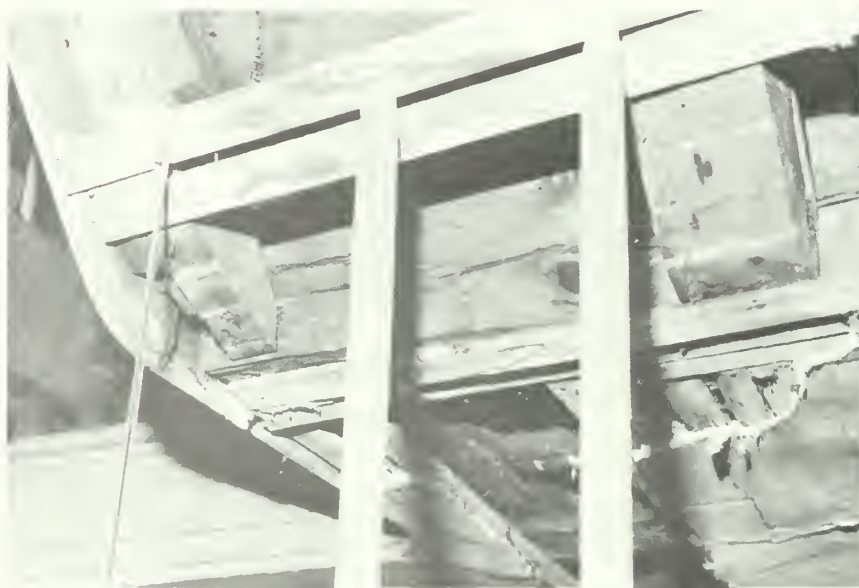
IP075, N041-06. Same area as IP069 (above), looking northwest and slightly up. Note stair stringers at top of picture. Horizontal joist is cantilevered from east wall. Tenon of previously mentioned stub joist appears at west end of cantilever above stair stringer.

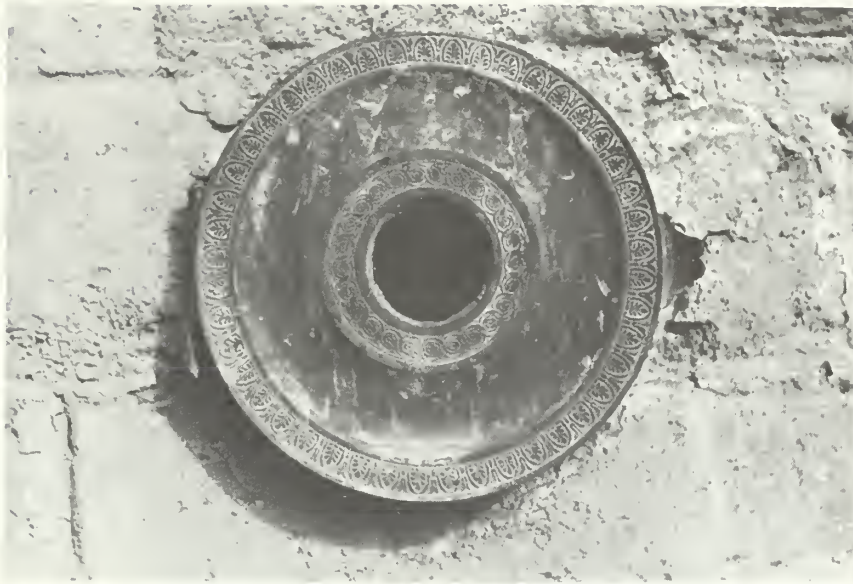
IP076, N015-16. Exterior cover for fresh-air intake duct.

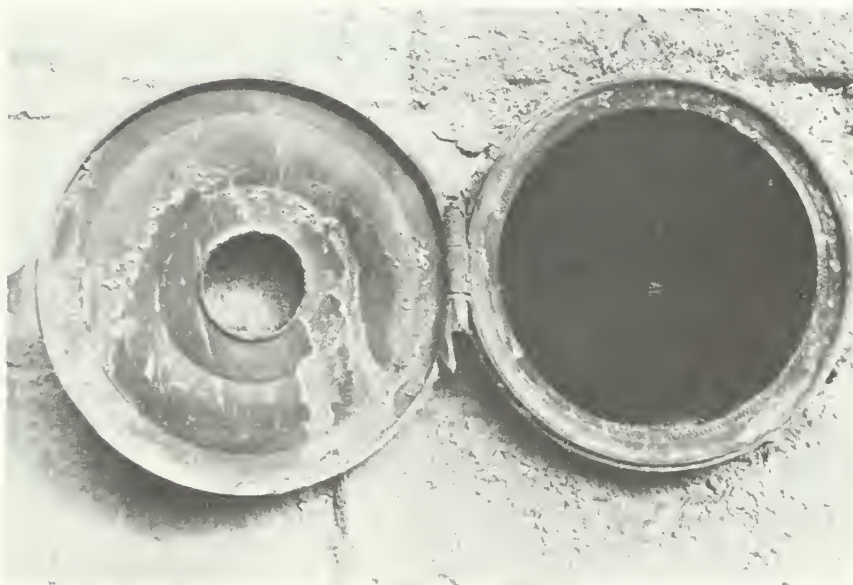
IP077, N015-17. Exterior cover in open position.

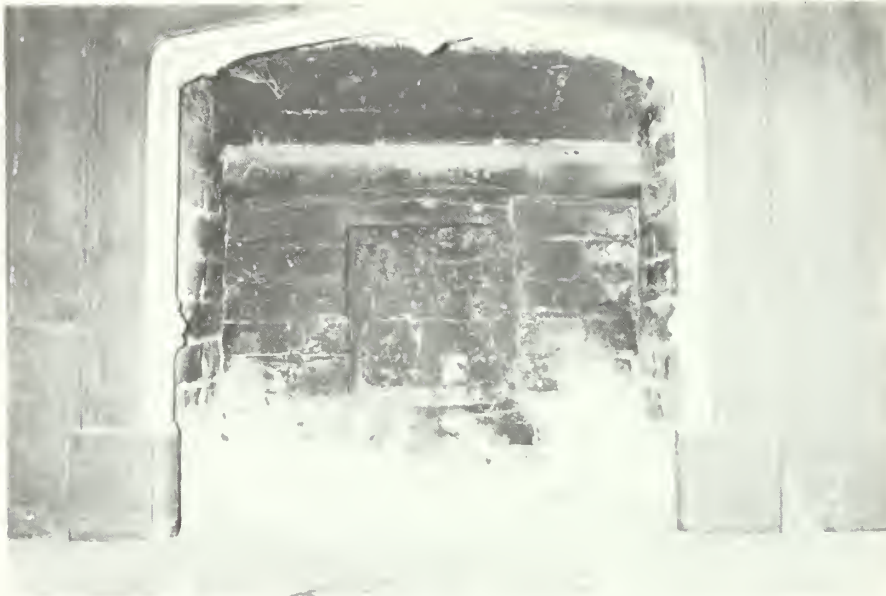
IP078, N023-19. Fireplace, room 109, with part of fresh-air heating apparatus in place.

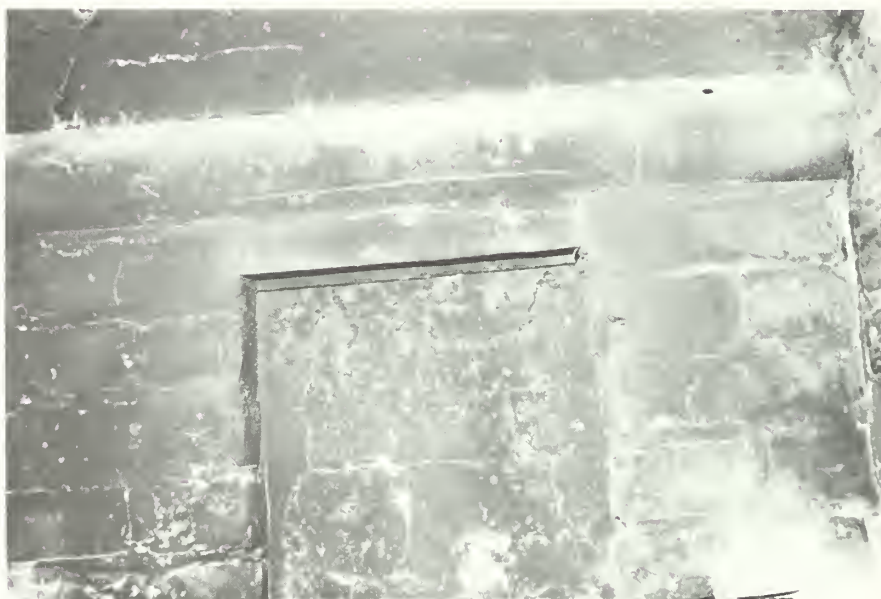
IP079, N023-21. Detail of IP073 (above) showing horizontal heat distribution duct and inlet from heating chamber.

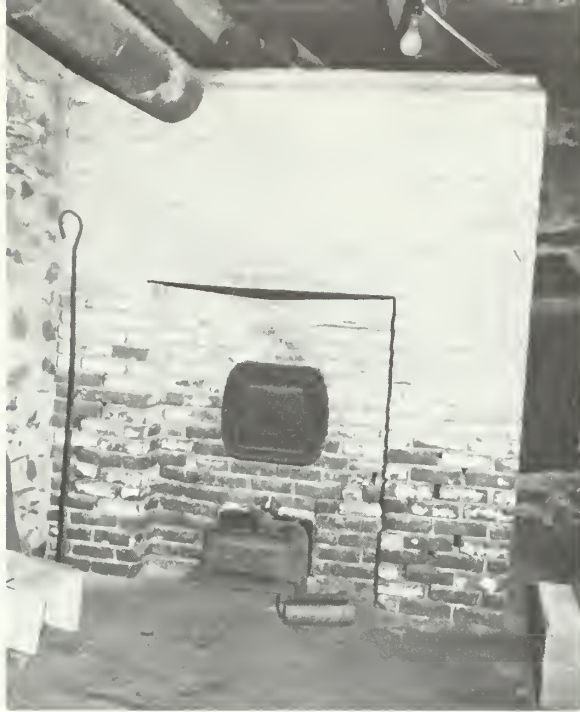
IP080, N018-06. East wall of furnace enclosure.

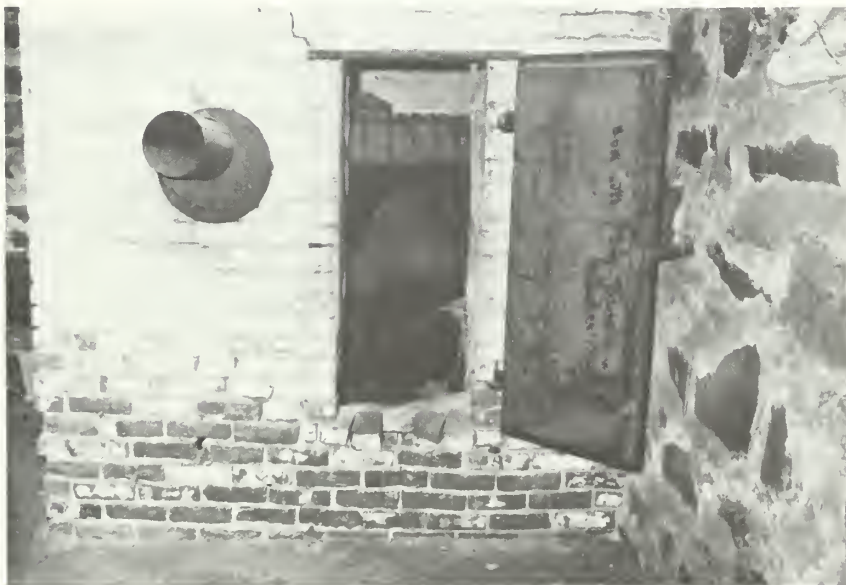
IP081, N010-05. North wall of furnace enclosure. Note inscription on door.

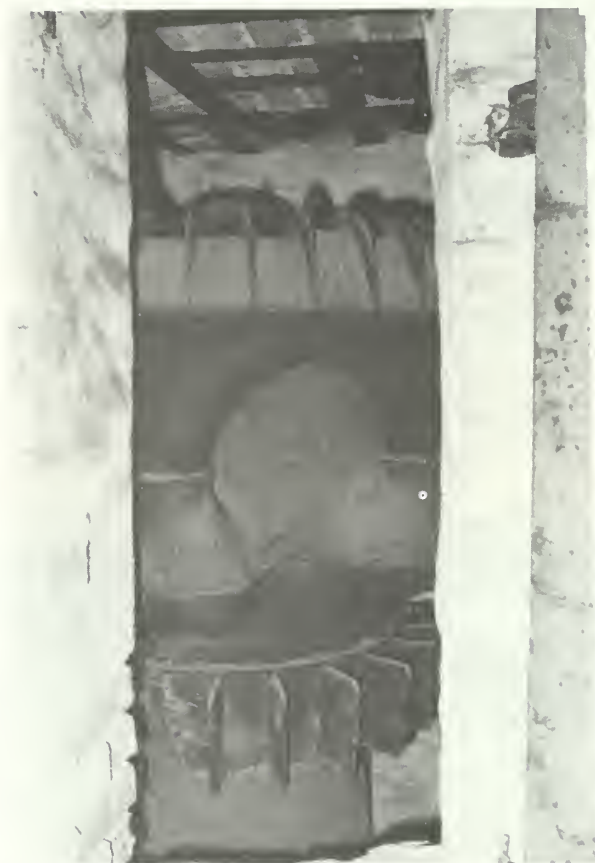
IP082, N010-07. Boynton's patent cast-iron furnace.

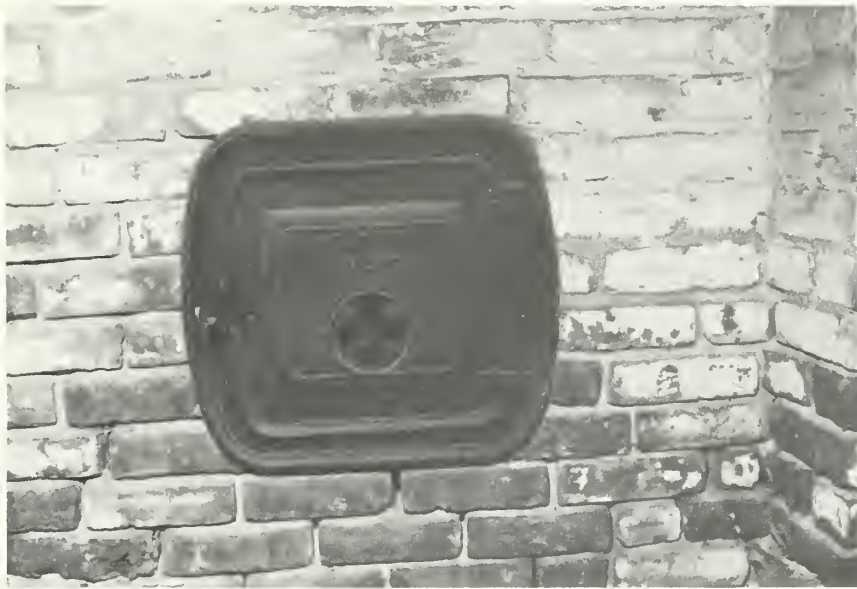
IP083, N010-04. Cast-iron fuel door with patent data.

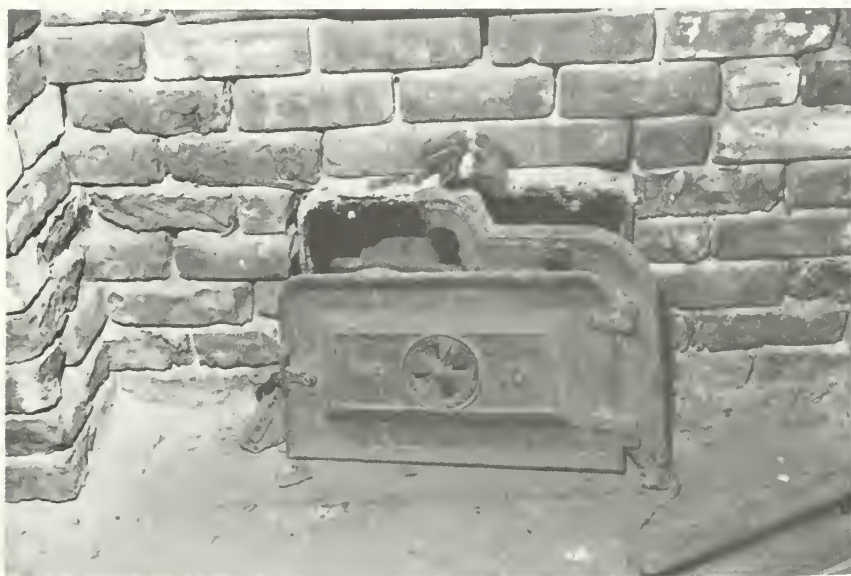
IP084, N010-10. Cast-iron ash cleanout door.

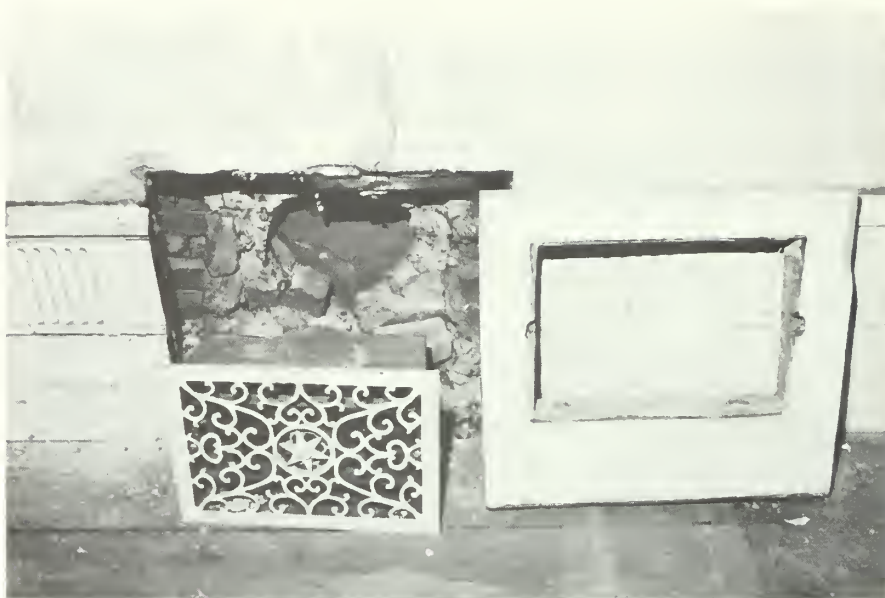
IP085, N022-22. Culver's patent register and marble frame, room 105, north wall.

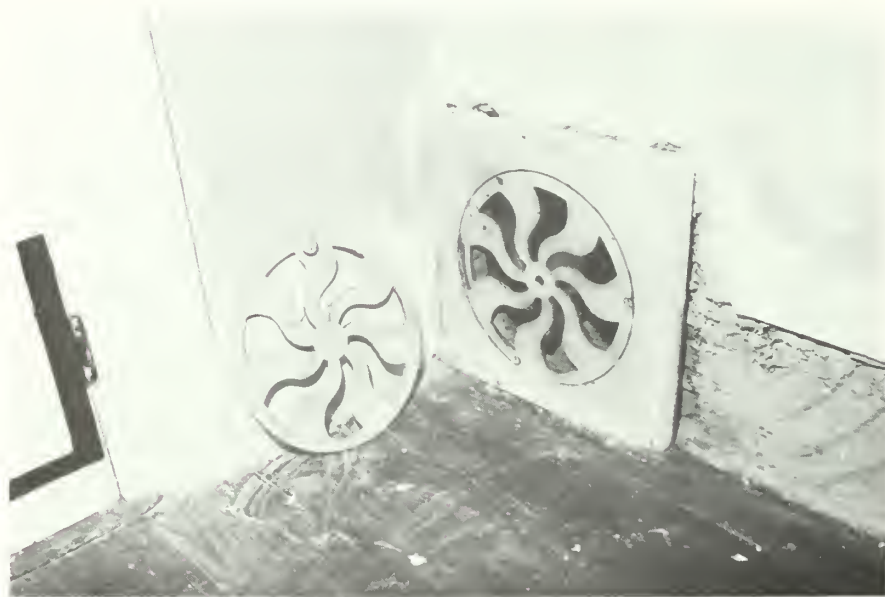
IP086, N031-11. Circular "sunflower" type register and frame, room 205.

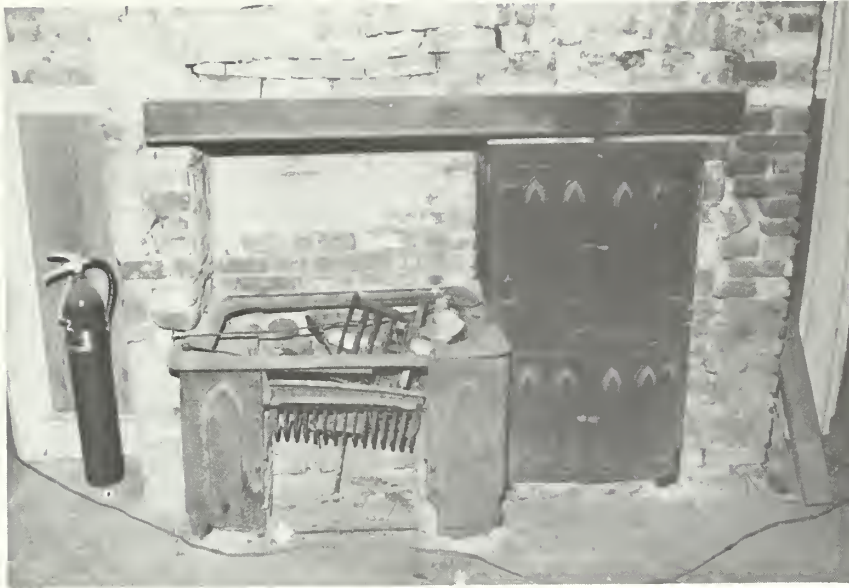
IP087, N017-22. Cook stove, room 006, north wall.

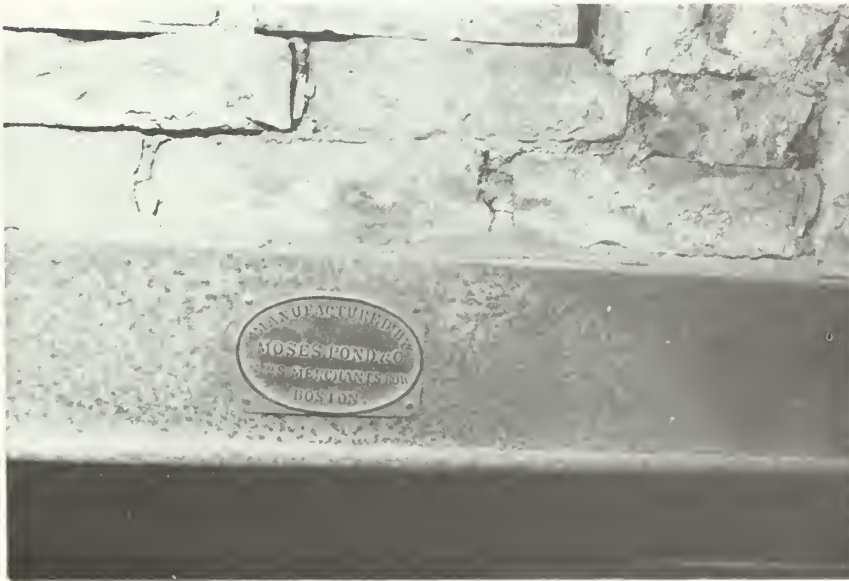
IP088, N017-23. Manufacturers label on hood over cook stove.

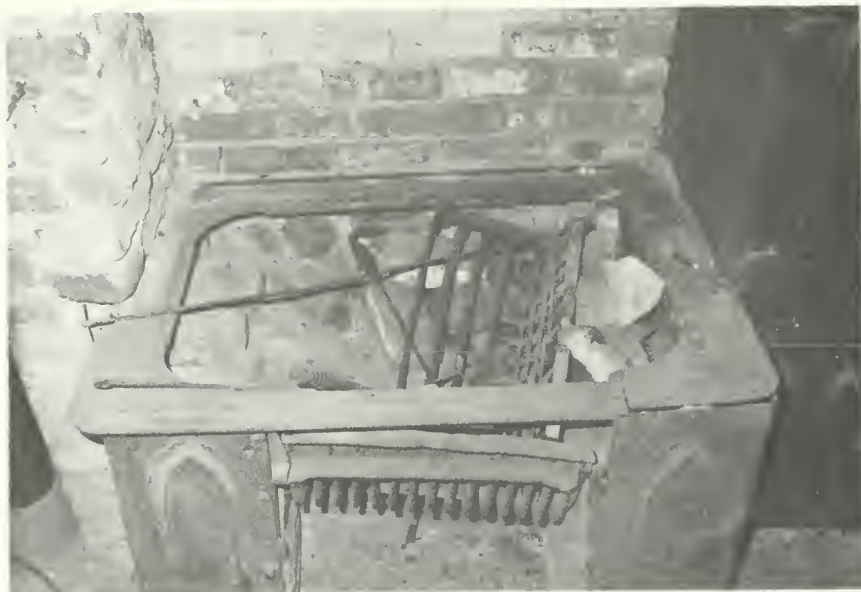
IP089, N017-26. Cooking surface.

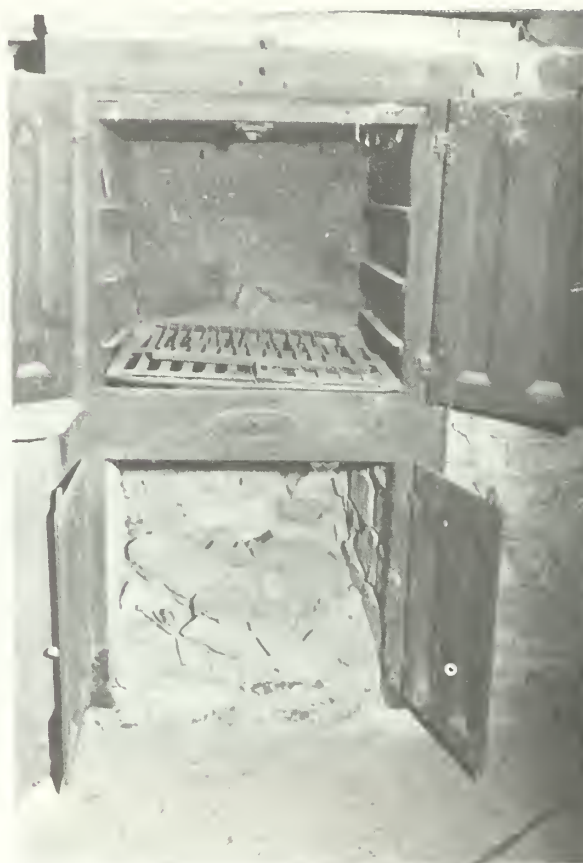
IP090, N017-28. Ovens.

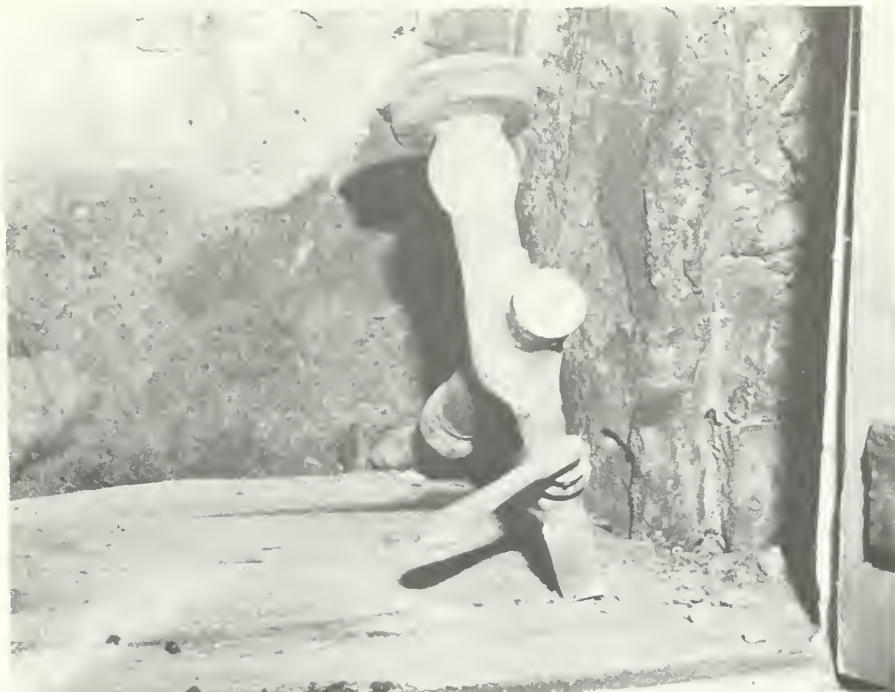
IP091, N038-01. Probable water supply to force pump, room 006, southwest corner at floor level.

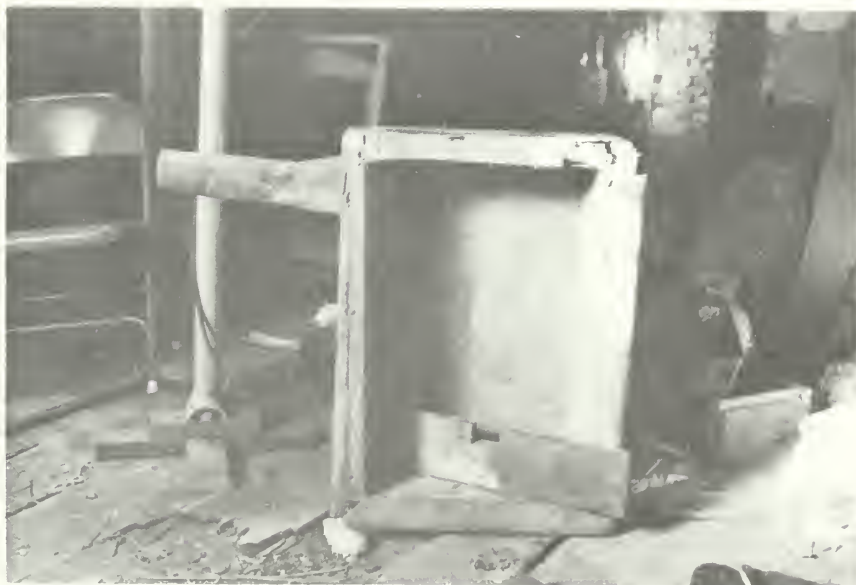
IP092, N001-08. Laundry room, room 007, sink.

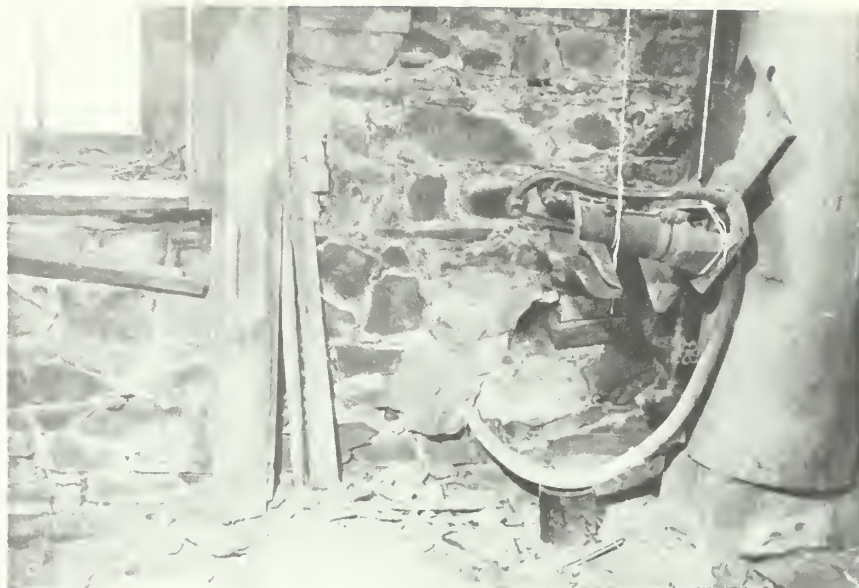
IP093, N001-09. Hand pump for laundry sink, room 007. Note hole in wall for drain.

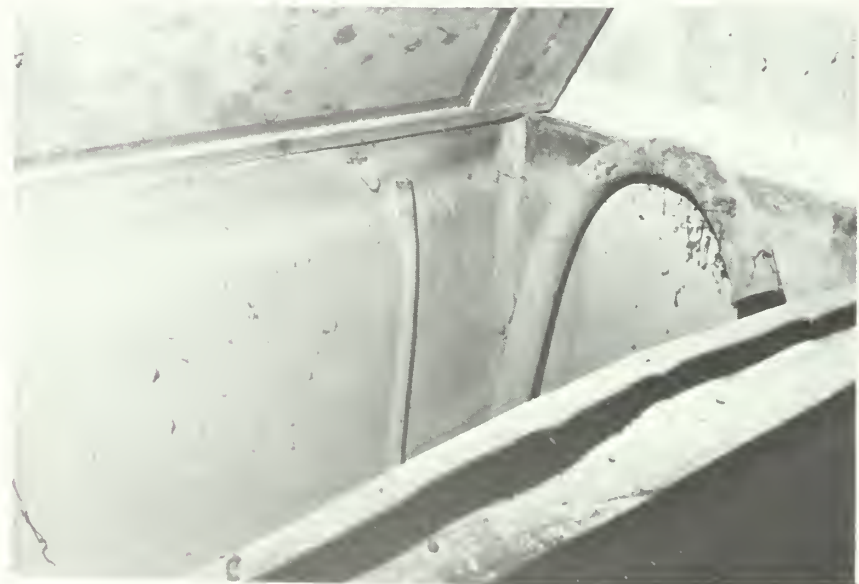
IP094, N018-17. Water tank, room 115, filler and overflow pipes.

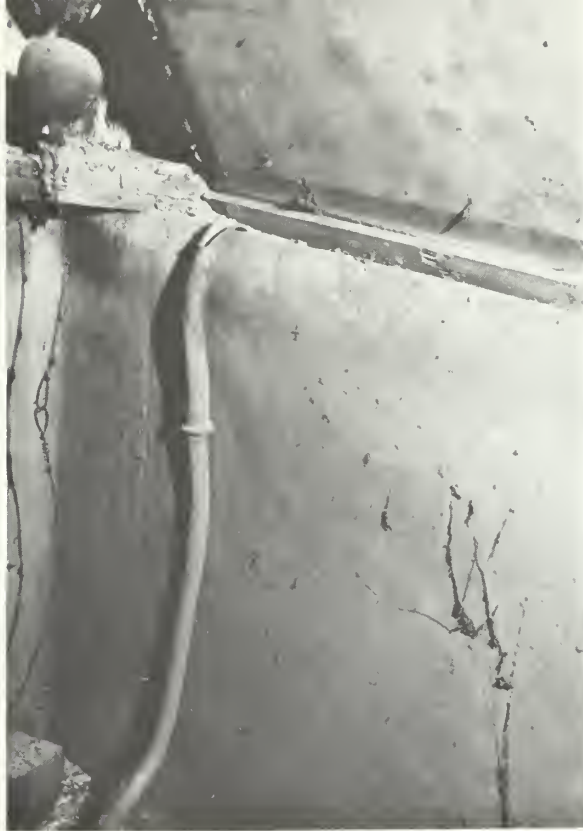
IP095, N018-18. Water tank, room 115, stopper lever and vacuum breaker pipe.

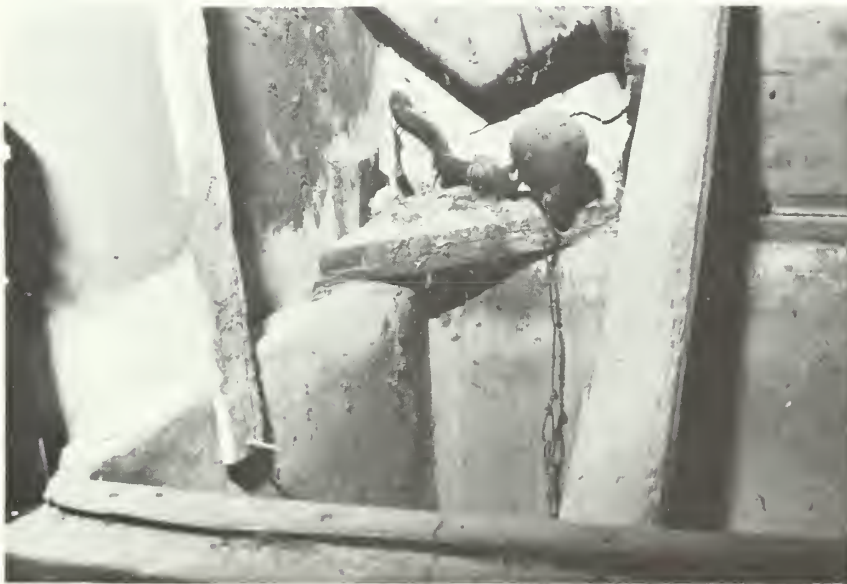
IP096, N018-16. Water tank, room 115, stopper lever.

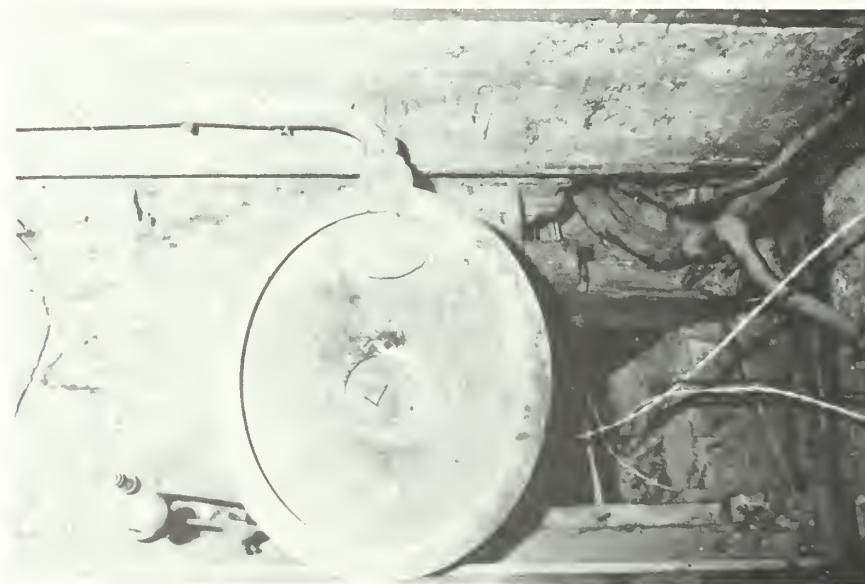
IP097, N018-20. Room 115 water closet and enclosure.

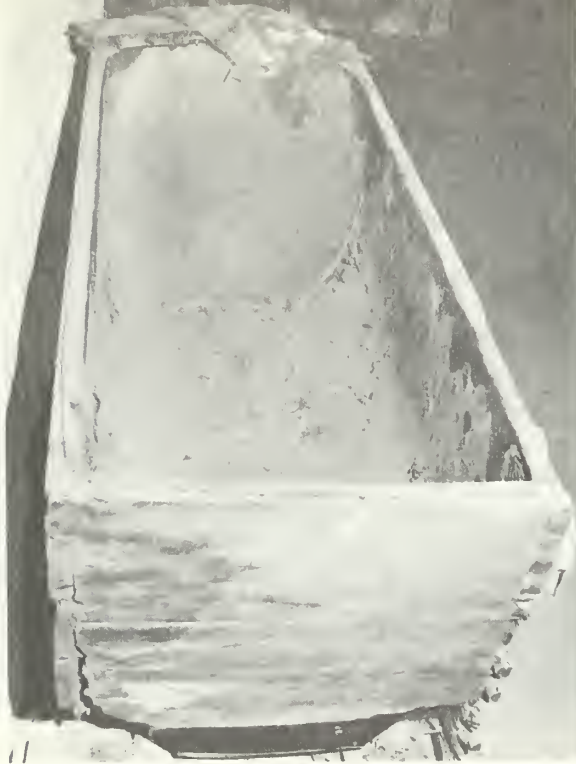
IP098, N036-03. Water closet with top removed.

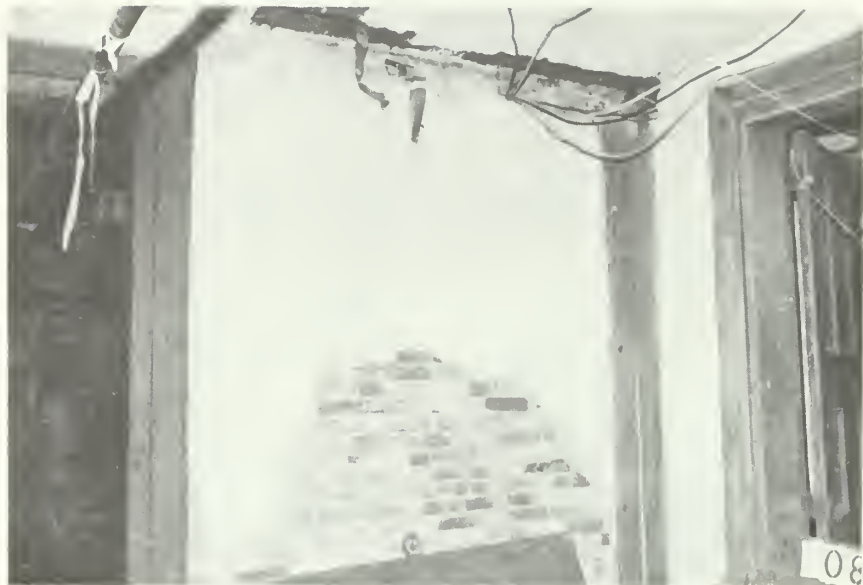
IP100, N009-18. Room 009, brick platform at southeast corner and stovepipe hole above.

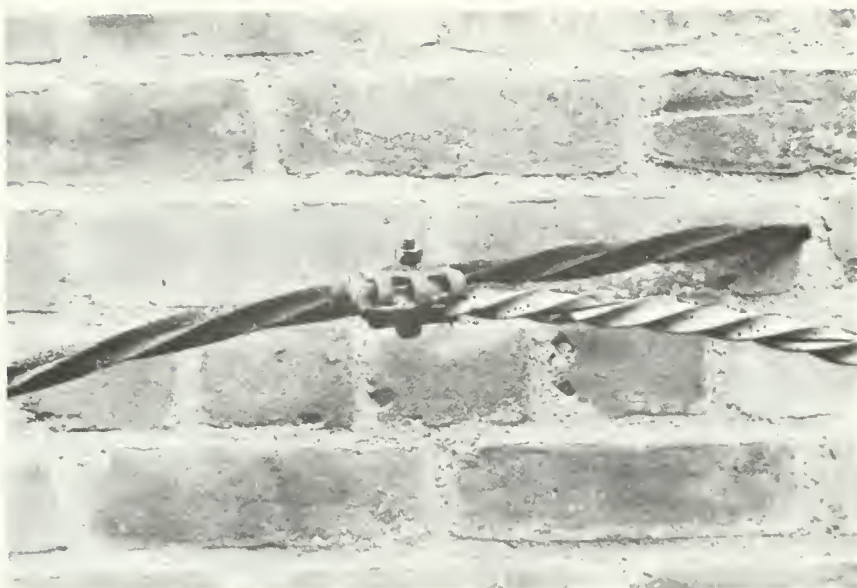
IP102, N031-36. Copper point attached to spiral fluted iron lightning rod.

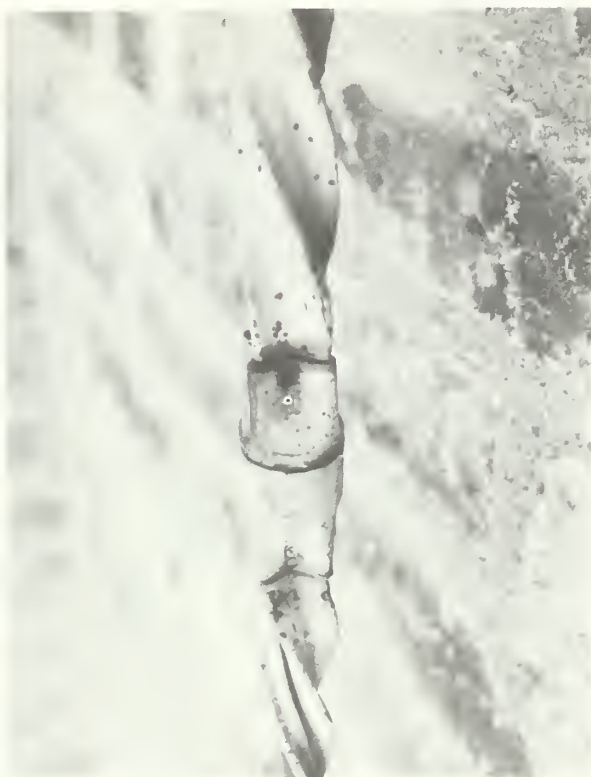
IP103, N050-12. Detail of iron lightning rod.

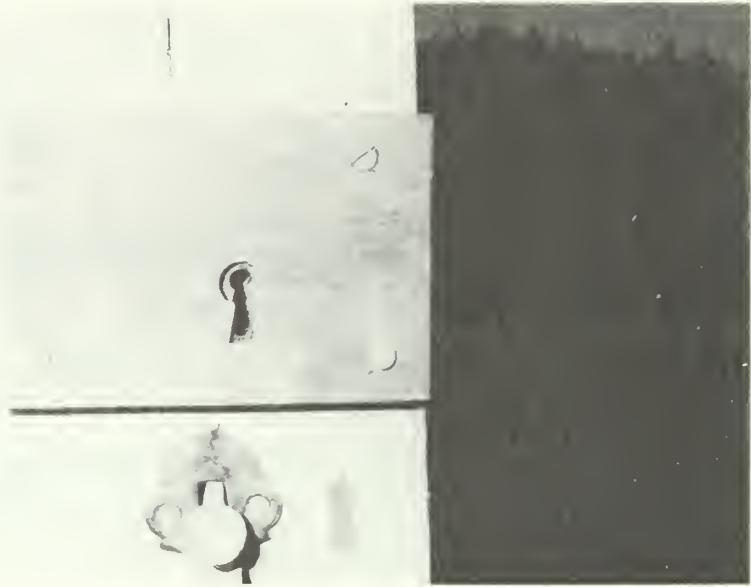
IP104, N034-9. Detail of more recent sheet copper spiral fluted rod with brass connectors marked "RHCO."

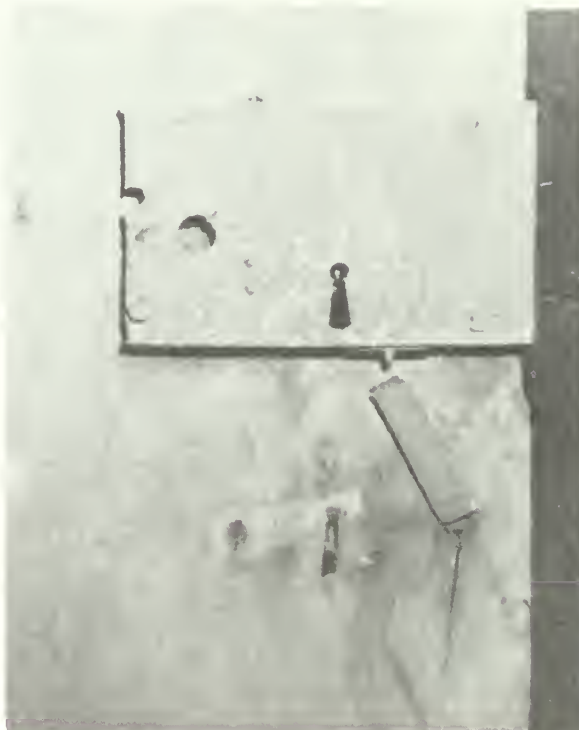
IP105, N037-24. Plate-type stock lock on door 301.

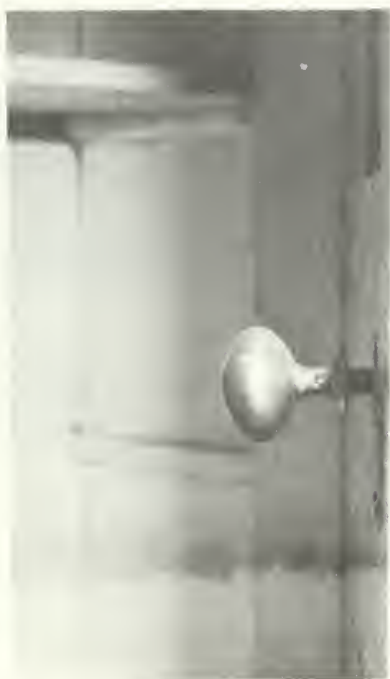
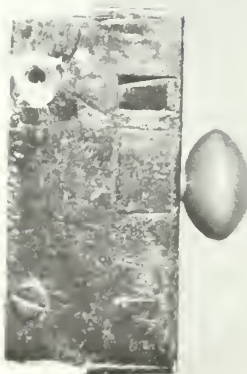
IP107, N038-05. Lock 210.

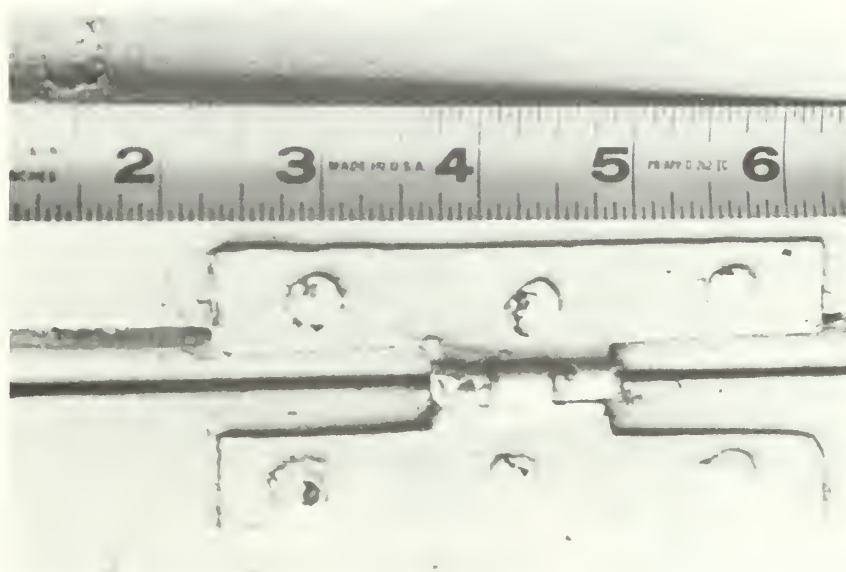
IP127, N027-25. Wrought-iron strap hinge typical for ca. 1797 basement board-and-batten doors.

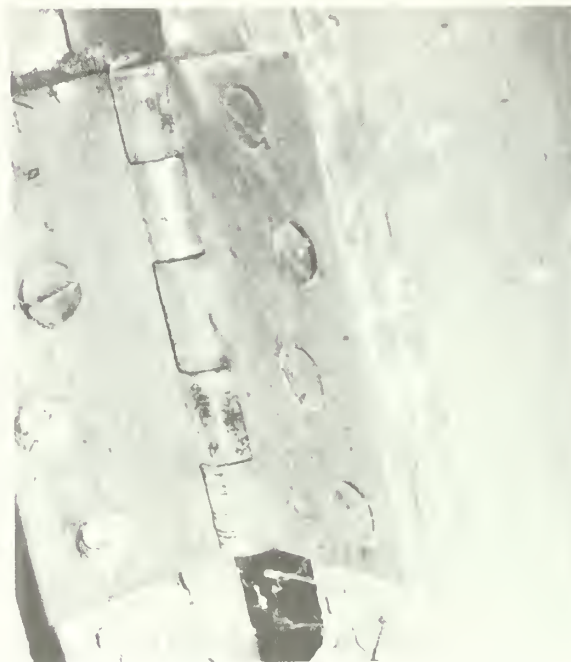
IP129, N030-06. Door 210, typical mounting of HL hinges on ca. 1797 door.

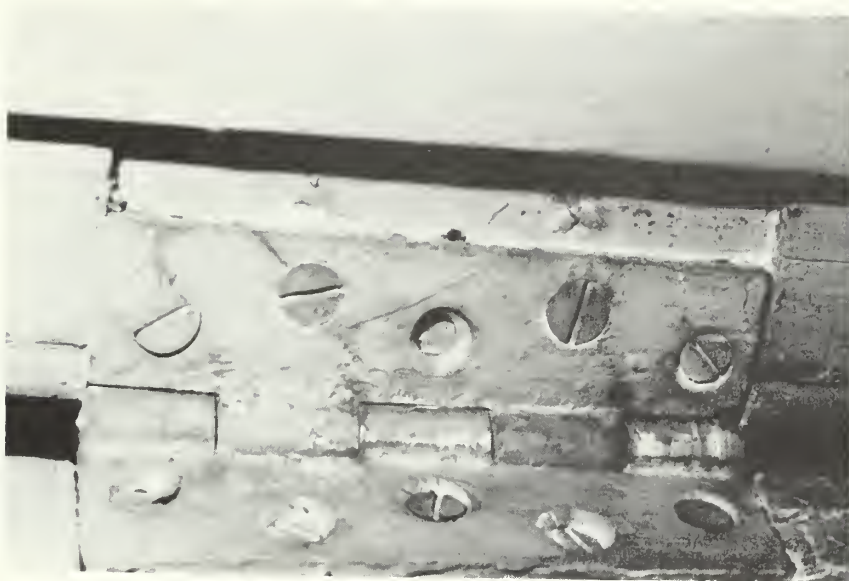
IP130, N037-28. 4" by 4" five-knuckle, eight-hole cast-iron butt hinge.

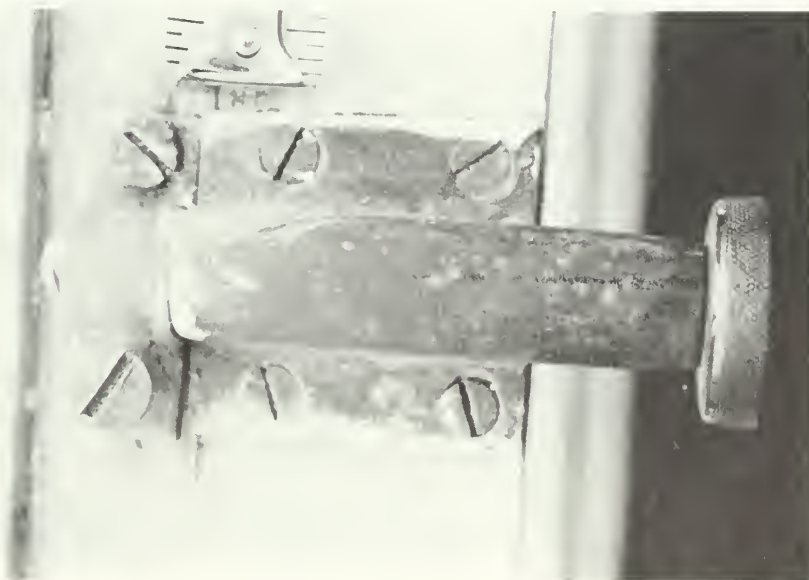
IP131, N037-27. 5" by 3" five-knuckle, ten-hole cast-iron butt hinge.

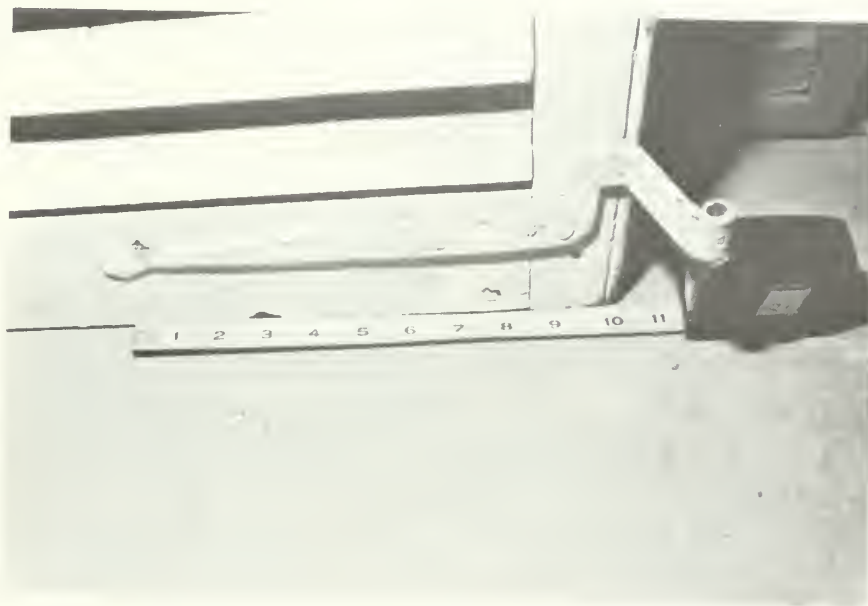
IP135, N036-26. Ca. 1850 sash lock.

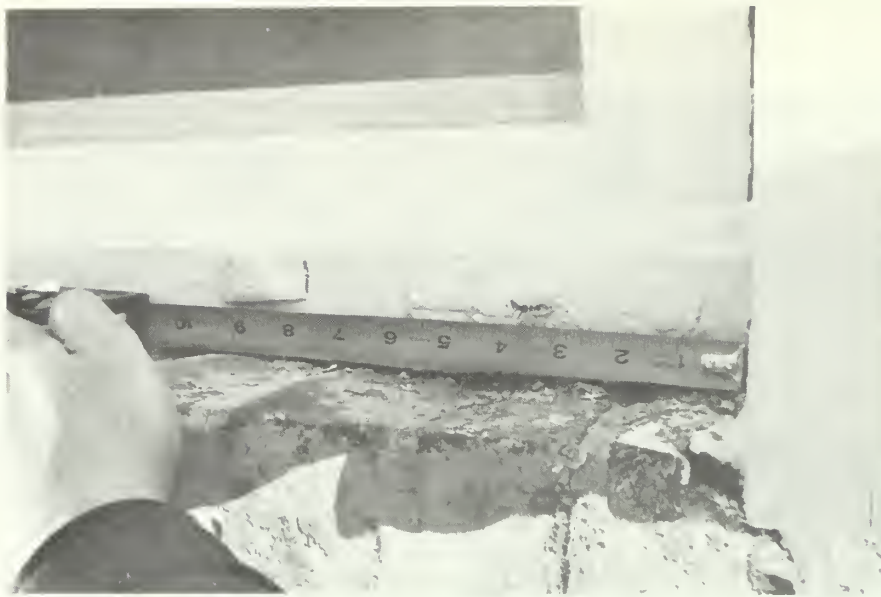
IP136, N033-16. Wrought-iron hinge for exterior shutter blind.

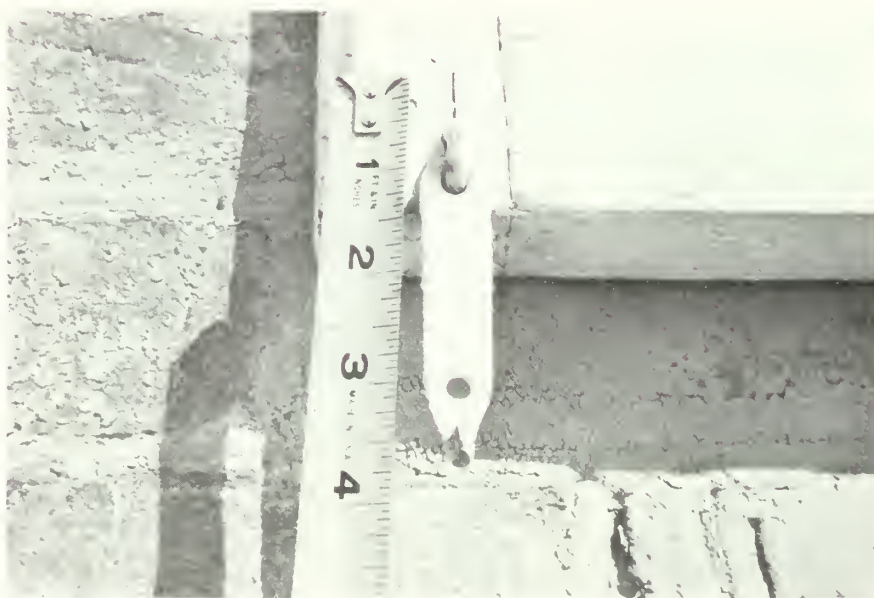
IP137, N034-04. Wrought-iron pintle for exterior shutter blinds.
